Single-Family Home Rainwater-Harvesting System Demonstration Project For Stormwater-Runoff Control and Utility-Water Saving

John Hammerstrom
American Rainwater Catchment Systems Association

Tamim Younos
The Cabell Brand Center for Global Poverty and Resource Sustainability Studies

Hammerstrom, J. and T. Younos. 2014. Single-family home rainwater-harvesting system demonstration project for stormwater-runoff control and utility-water saving. The Cabell Brand Center Special Report No. 100-2014, 34 pp.

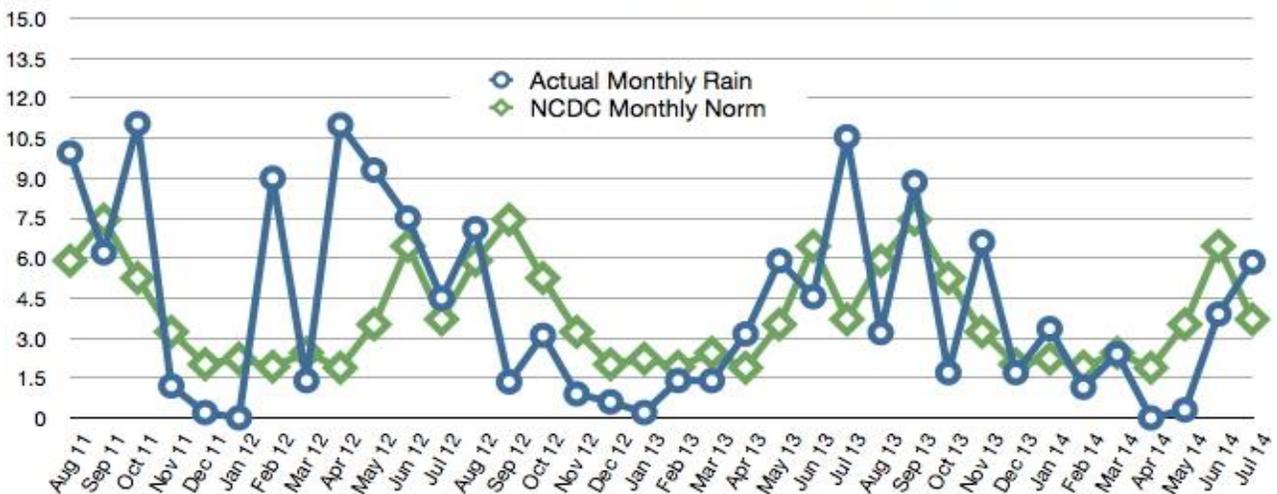
Figure 1 - Monthly Rainfall vs. NCDC Monthly Norm

Rainfall for the three-year study period (8/1/2011 to 8/1/2014) was measured regularly and after rain events, using a common garden rain gauge. According to the National Climatic Data Center (NCDC – www.ncdc.noaa.gov), the 30-Year (1981-2010) Monthly Normal precipitation for nearby Tavernier, Florida, was 45.95 inches. For the period of the study at the project demonstration site, the average annual rainfall was 50.2 inches per year. The rainfall (Figure 1) during this study did

not follow the historical patterns in February through May 2012, when greater than average seasonal rain fell. The longest periods without rain were 58 days between December 2011 and

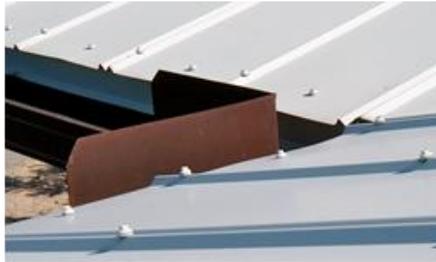
Figure 2

Components of the rainwater capture system include a 1,956 square-foot white metal Galvalume™ roof with 6-inch copper gutters and splash guards (Figure 2); Schedule 40 PVC downspouts and conveyance; a pre-filtration and first-flush system (Figure 3); calming inlets (Figure 4); and a 7,500-usable-gallon, ground-level poured concrete tank which is integrated into the concrete home structure (Figures 5a and 5b). The total volume of the storage tank is 10,000 gallons, with usable volume diminished by unusable water below the foot valves and dead space above the overflow. The tank is separated into two halves by an internal concrete wall with overflow gaps at the top, such that when the first half is full, rain overflows to the second half. When the second half is full, the tank overflows passively to a spreader swale (Figure 6).

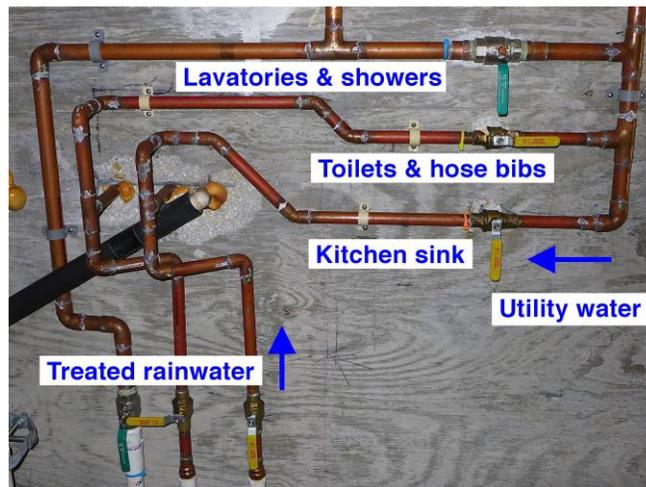
Figure 7. Utility water and rainwater dual-use system

The dual-use (rainwater and utility water) distribution system shown in Figure 7 incorporates three subsystems that can supply either utility water or treated rainwater (see Section 2.4) to (any or all of): 1) a dedicated single faucet in the kitchen for drinking and cooking; 2) all lavatories and showers; 3) toilets and hose bibs. Figure 7 shows the utility-water source at the top of the picture, with three on-off ball valves, and the treated rainwater source at the bottom, each with three valves paired to its utility-water counterpart.

The three subsystems can be manually switched as follows: a) when rain is plentiful during the rainy season, use rainwater for all inside and outside household potable and non-potable purposes; b) when rainwater tank levels decline, use utility water for hose bibs and toilet flushing, and use treated rainwater for drinking, showering and cooking; c) and when rainwater tank level is low during the dry season, direct treated rainwater for use in the kitchen sink (for drinking and cooking), and use utility water for all other purposes.

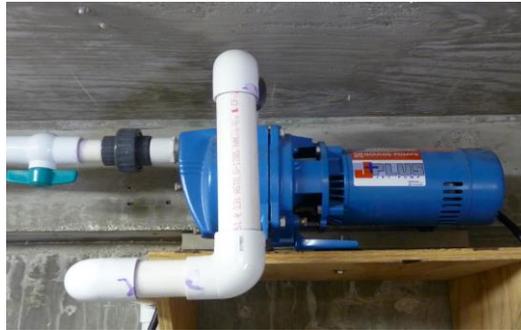
Figure 9

both foot valves by a $\frac{3}{4}$ hp Jet Pump shown in Figure 9. Water pressure is maintained by an 80-gallon pressure tank (Figure 10). For treatment, rainwater flows from left to right through the three canisters of a Pura Big Boy UVBB3, filtration, and 115-volt ultraviolet system (Figure 11). The first canister houses a dual-density polypropylene sediment filter, (nominal 25-micron pre-filtration and 1-micron post filtration), the second houses a 5-micron nominal carbon block and the final canister is the UV chamber for disinfection (Figure 11). After final treatment, the treated rainwater flows through the selection valves (Fig. 7) to the household fixtures.

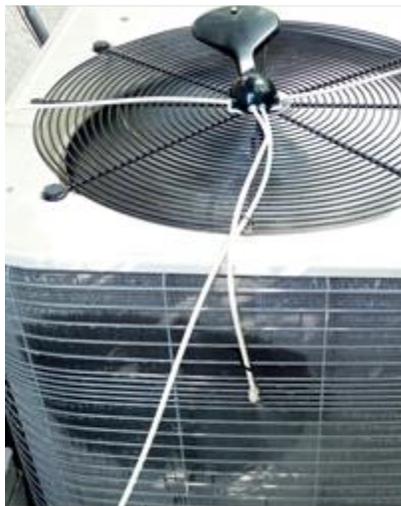
Figure 12

Onsite uses of treated rainwater include uses typical of a residence, from landscape and toilet flushing to ice making. The home is equipped with dual-flush toilets, with the low-flush and high-flush used normally for liquids and solids respectively, but the high flush being used for both purposes during the rainy season to accelerate consumption. In South Florida, the rainy season is also the hot season. Between May or June and November (depending on when the rains begin), rainwater was used as the source for a "Cool-N-Save" air conditioning pre-cooling mist system (Figure 12) to reduce energy consumption and to reduce overflows.

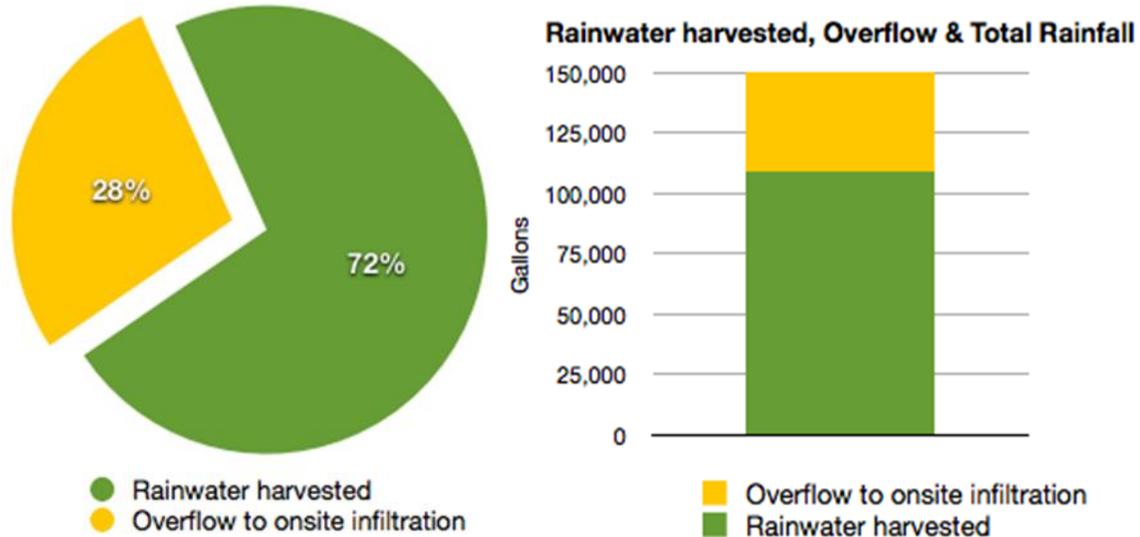
Figure 13 Harvested rainwater and use

Seventy-two percent (72%) of the total 150,500 gallons of rain that fell on the rooftop—or 108,850 gallons—was captured for household and landscape uses (Figure 13). The remaining 41,650 gallons (28%) was overflowed to an onsite spreader swale (Figure 6). Thus, the residential water system allowed for total onsite use of rooftop rainwater with near zero stormwater runoff.

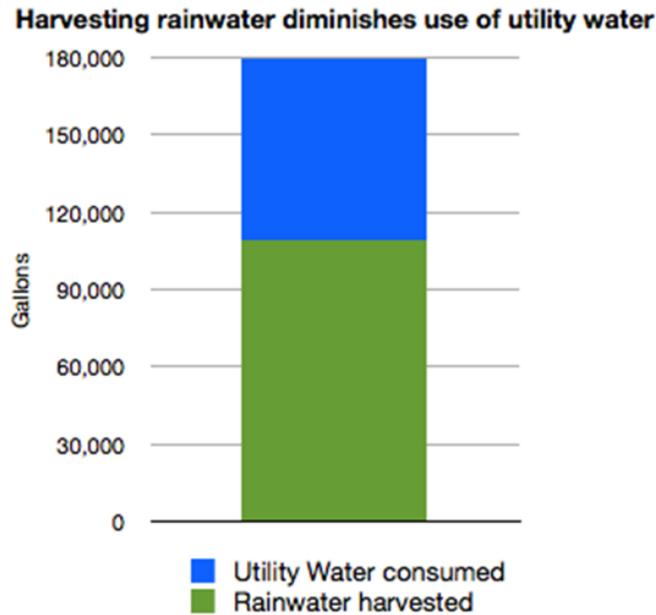
Figure 14. The impact of rainwater harvesting on utility water consumption

Figure 14 shows the impact of rainwater harvesting on utility water consumption. Of the total 183,077 gallons of water consumed during the three years, 108,850 gallons (59%) was provided by harvested rainwater. As a result of rainwater use, utility water consumption was 33.9 gallons per capita per day (gpcd) compared to the utility-wide average of 107 gallons per capita per day. Both treated rainwater and utility water were used during the study period and the combined total water usage was 83.6 gallons per day per capita, still below the average utility-wide consumption, but below that of water-conserving homes, due in part to the intentional accelerated consumption (creating tank capacity) to avoid potential runoff.
